Manhole Inspection Summary

Manhole # S15EE1022MH

Insp Date: **3/6/07 11:07 AM**

Location Address: **2525 KEYWORTH AVE**

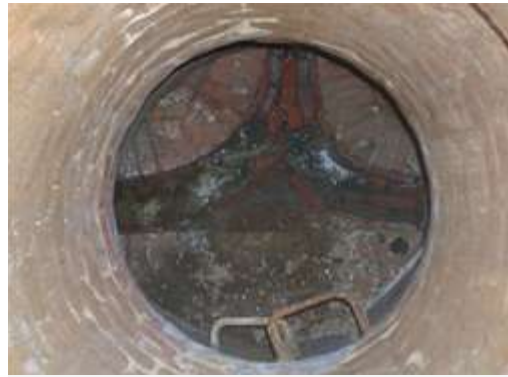
Top View

Corroded steps. Evidence of surcharge - Bench debris. Channel debris.

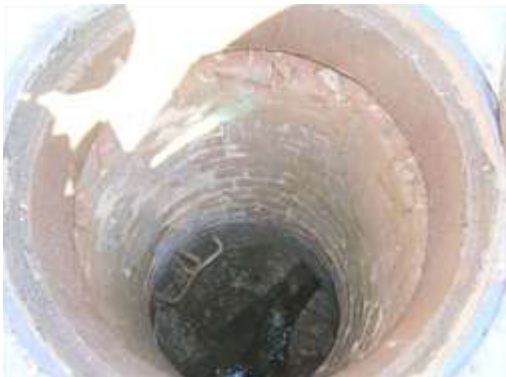
Defect

Frame offset. Adjustment deterioration and infiltration. Corbel and Barrel infiltration.

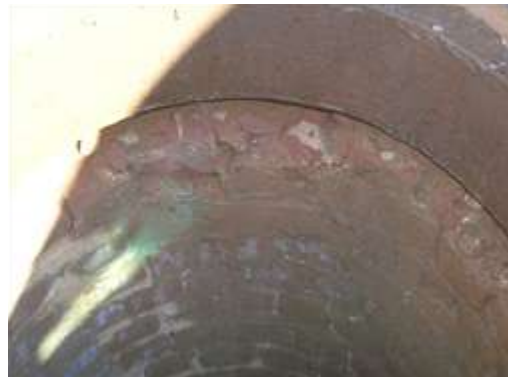
Defect

Frame leaks. Adjustment deterioration and infiltration.

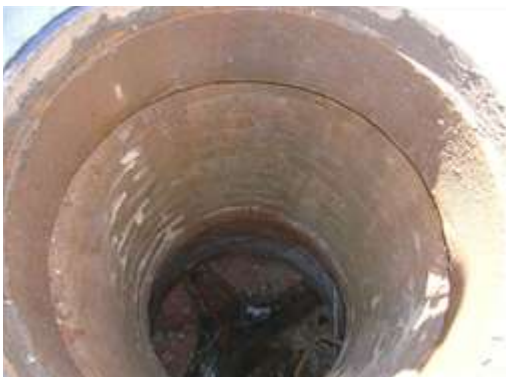
Defect

Frame leaks. Adjustment, Corbel and Barrel infiltration.

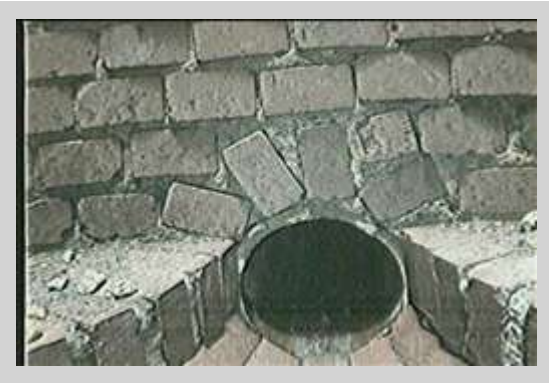
8 in. Circular Gravity Sewer Pipe Out @ 12 O'Clock

Barrel deterioration and infiltration. Channel deterioration.

Invert Depth: **10.21** (ft.) Flow Characteristics: **Slow**

Deposits: ☐ None ☐ **Mud** ☐ Sludge ☐ **Debris** ☒ **Grease**

Silt Depth: **0** (in.) Deposits Extent: **Light**

Infiltration: **Evidence** Pipe Seal Cond: **Unknown**

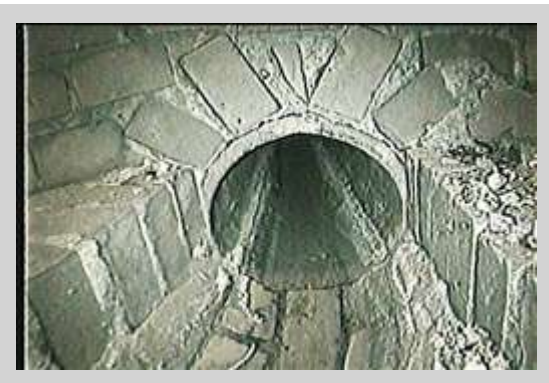
8 in. Circular Gravity Sewer Pipe In @ 3 O'Clock

Invert Depth: **10.04** (ft.) Flow Characteristics: **Slow**

Deposits: ☐ None ☐ **Mud** ☐ Sludge ☐ **Debris** ☒ **Grease**

Silt Depth: **0** (in.) Deposits Extent: **Light**

Infiltration: **Evidence** Pipe Seal Cond: **Unknown**

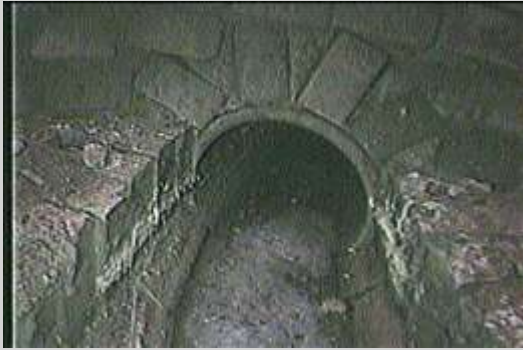
Pipe In @ 9 O'Clock

Invert Depth: **10.06** (ft.) Flow Characteristics: **Slow**

Deposits: ☐ None ☒ **Mud** ☐ Sludge ☒ **Debris** ☒ **Grease**

Silt Depth: **0.5** (in.)

Deposits Extent: **Light**
